## **Preliminary Report**

**Accident involving Air India's B787-8 aircraft bearing registration VT-ANB  
at Ahmedabad on 12 June 2025**

**Government of India  
Ministry of Civil Aviation  
Aircraft Accident Investigation Bureau**

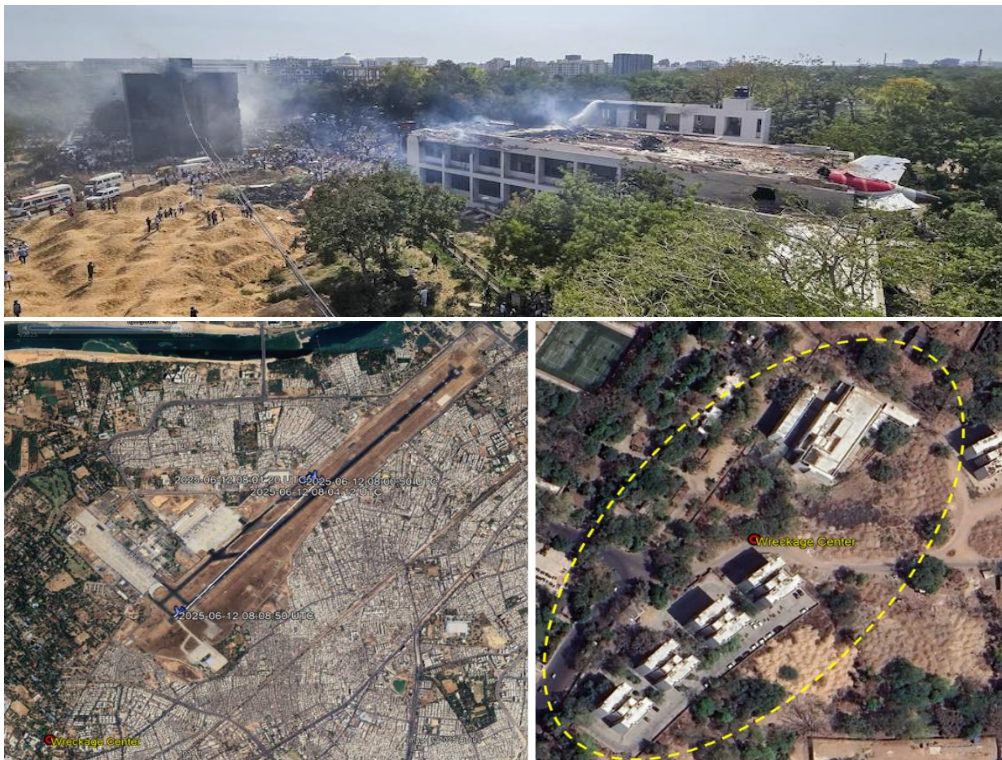
Figure 1 Accident Site with respect to airport (left) and debris field

The Aircraft was destroyed due to impact with the buildings on the ground and subsequent fire. A total of five buildings shown in the figure below were impacted and suffered major structural and fire damages.

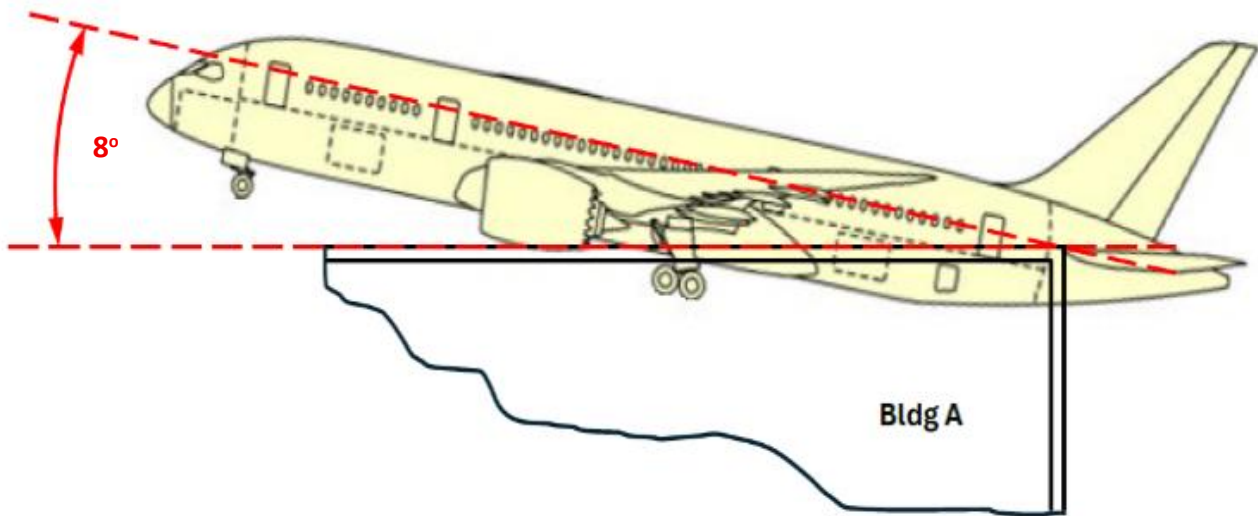
Figure 3 Aircraft attitude at the time of impact with Building A

As the aircraft was losing altitude, it initially made contact with a series of trees and an incineration chimney inside the Army Medical Corps compound before impacting the northeast wall of the Building A. The distance between the tree on which the aircraft made its initial contact and the point on the Building A where the aircraft impacted is 293 ft. As the

aircraft moved forward, it continued fragmenting and collided with other structures and vegetation. The impact witness marks on the building and airplane indicated a likely nose-up attitude (about 8°) and wings level.

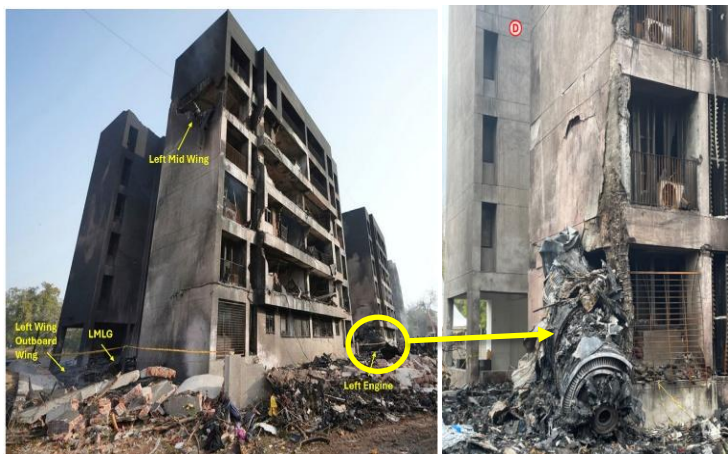
Figure 8 LH Engine

The left main landing gear (LH MLG) and left wing outboard and middle section struck building C, came to rest approx. 345 feet south from the initial point of contact. (*fig. 8*). The left wing middle section of the wing was stuck in the north corner of the fourth floor of the Building C while the left wing inboard section was lying about 670 feet southwest of the initial point of contact with the Building A. (*fig. 8*).

The left engine (*fig.8*) got separated from the airplane and struck the north corner of Building D at the ground level where it remained and was roughly perpendicular to the right engine resting position, at heading of approx. 326 degrees. The wall was pushed into the

building and the northwest building column was damaged such that portions of the concrete

were missing and exposing the internal metal rebar. The engine, remaining portions of attached cowling, and the surrounding area were heavily damaged by fire.

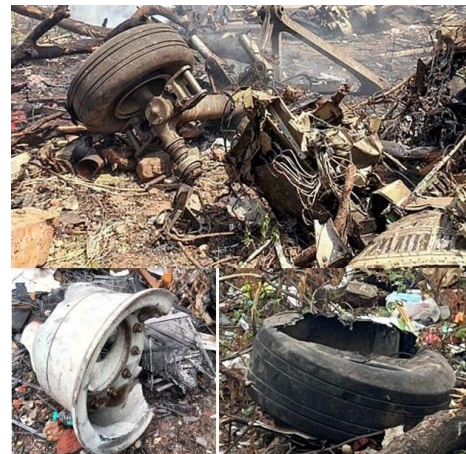
Figure 9 Nose Landing Gear

The nose landing gear (NLG) (*fig. 9*) was found on the ground about 307 feet southwest from the initial point of contact with Building A.

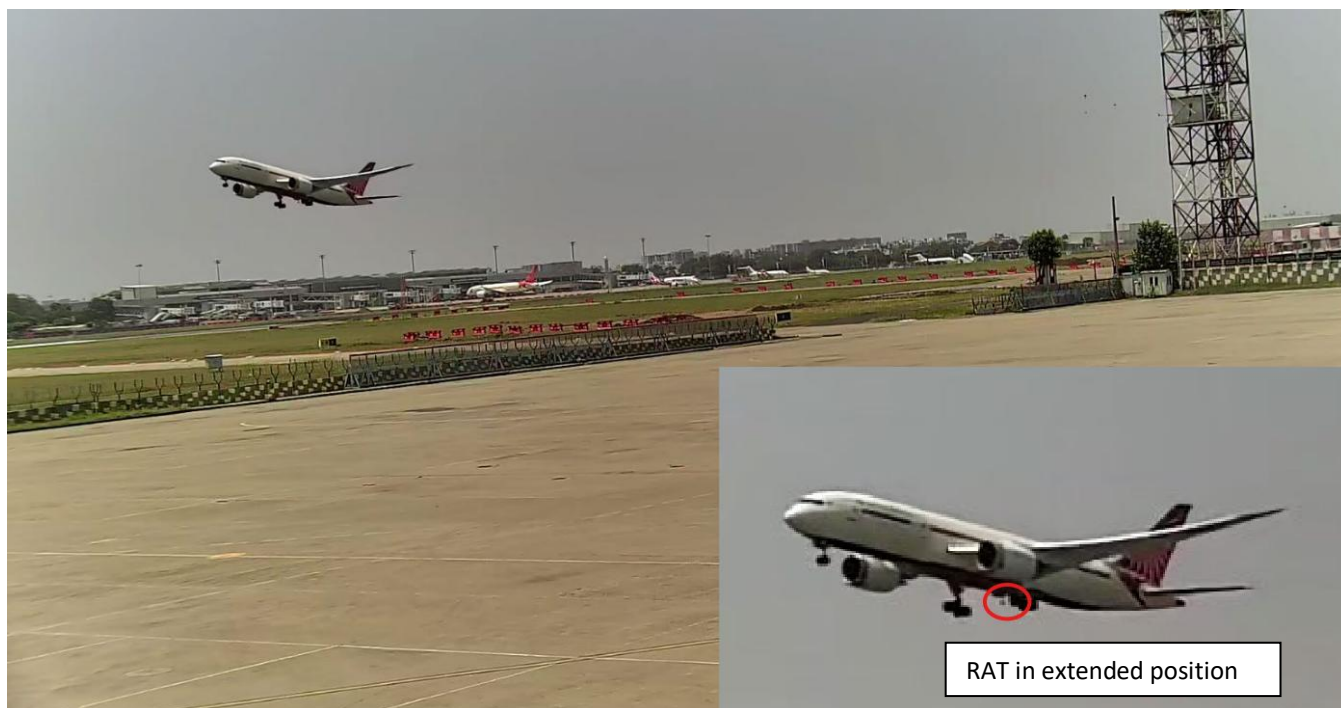
Figure 15 CCTV screenshot of RAT Deployment

The CCTV footage obtained from the airport showed Ram Air Turbine (RAT) getting deployed during the initial climb immediately after lift-off (*fig. 15*). No significant bird activity is observed in the vicinity of the flight path. The aircraft started to lose altitude before crossing the airport perimeter wall.
